AEDC-TR-67- 256

QUALIFICATION TESTS OF
THIOKOL CHEMICAL CORPORATION TE-M-364-3
SOLID-PROPELLANT ROCKET MOTORS
TESTED IN THE SPIN AND NO-SPIN MODE
AT SIMULATED ALTITUDE CONDITIONS
(PART II - FINAL PHASE)

ARNOLD ENGINEERING DEVELOPMENT CENTER

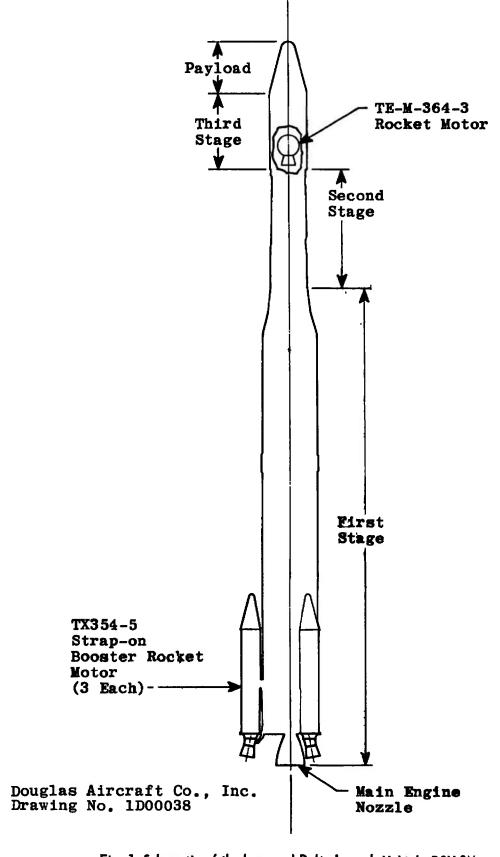
Fig. 1 Schematic of the Improved Delta Launch Vehicle DSV-3M

The Thiokol Chemical Corporation (TCC) TE-M-364-3 solid-propellant rocket motor is to be used as the third stage of the Improved Delta Launch Vehicle, DSV-3M (Fig. 1, Appendix I). Delta missions scheduled to utilize the TE-M-364-3 motor include Radio Astronomy Explorer (RAE), Interim Defense Communications Satellite program (IDSEP) International Tele-communications Satellite Program (Intelsat III), and the Tiros Operational Satellite (Tiros M) (Ref. 1). For each of these third-stage and payload combinations, attitude control will be achieved by spin stabilization.

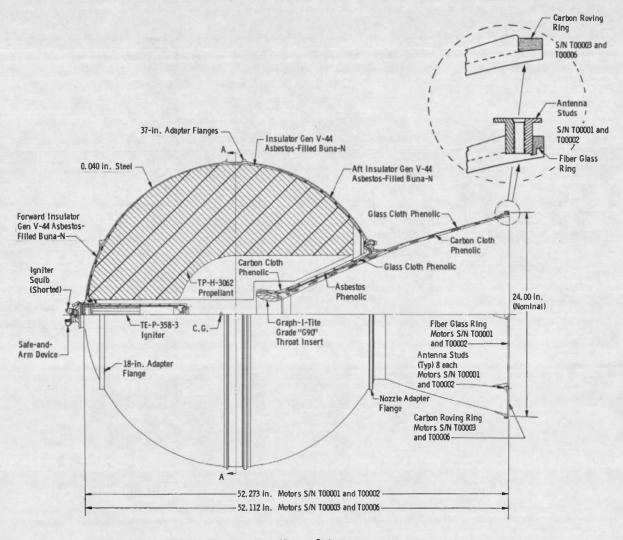
a. Motor Schematic

Fig. 2 TE-M-364-3 Rocket Motor

The cylindrical motor case is constructed of 0.040-in. steel. The aft hemisphere and approximately one-half of the forward hemisphere regions are insulated with V-44 asbestos-filled Buna-N® rubber. The remaining case area is uninsulated (Fig. 2a). Two 37-in.-diam thrust attachment flanges are located near the motor equator.

The contoured nozzle assembly contains a Graph-I-Tite G-90 carbon throat insert and an expansion cone constructed of outer layers of glass cloth phenolic and inner layers of carbon cloth phenolic. The partially submerged nozzle assembly has a nominal 53:1 area ratio (A/A\*) and a 15-deg half-angle at the exit plane. Eight aluminum antenna studs and a fiber glass stiffner (support) ring are normally bonded to the nozzle expansion cone adjacent to the exit plane. For motors S/N T00003 and S/N T00006, the existing nozzles were modified by removing the antenna studs and the fiber glass bands, shortening the expansion cones at the exit plane by 0.161 in., and thereby increasing the exit cone thickness at the exit plane from 0.094 to 0.134 in. The fiber glass bands were replaced with carbon roving bands which were pre-impregnated with a modified phenolic resin (Fig. 2a).

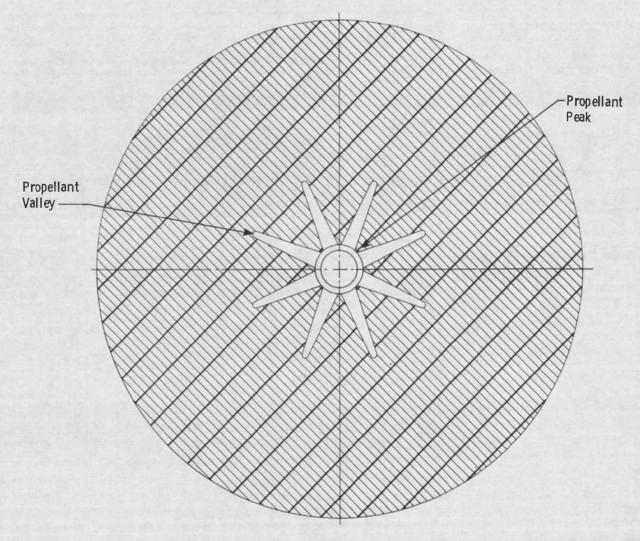
b. Propellant Schematic (Section A-A)

The TE-M-364-3 rocket motor contains a propellant grain formulation designated TP-H-3062 (ICC Class B), which is cast in an eight-point-star configuration (Fig. 2b). The isentropic exponent of the propellant exhaust gases is 1.18 (assuming frozen equilibrium).

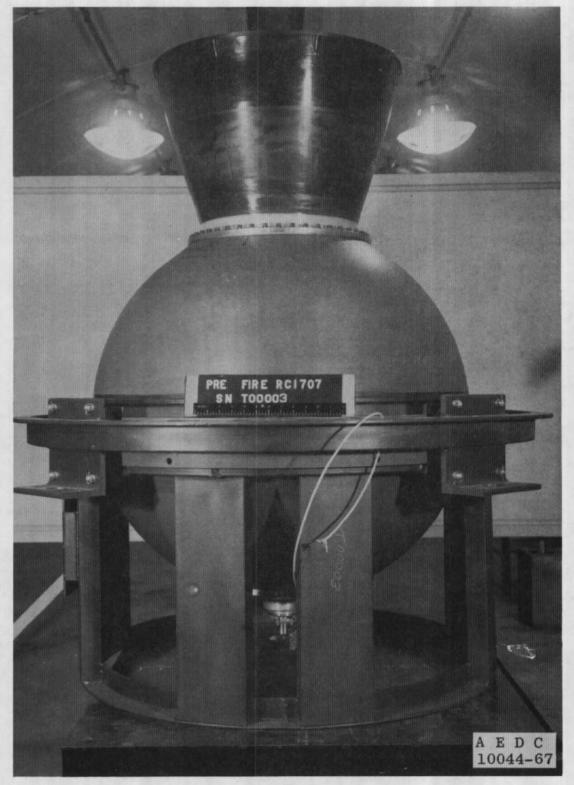
c. Motor Photograph
Fig. 2 Concluded

The TCC TE-M-364-3 solid-propellant rocket motor (Fig. 2) is a full-scale flightweight motor having the following nominal dimensions and burning characteristics at 75°F:

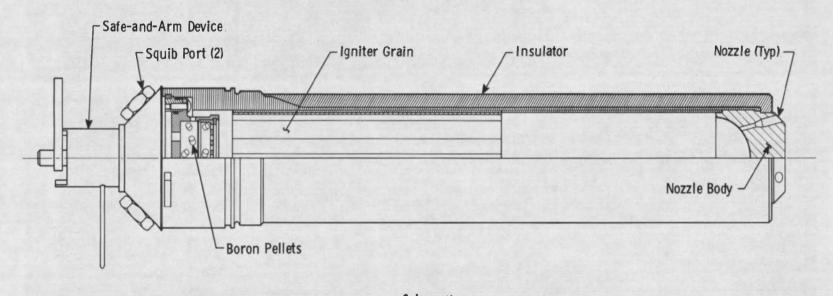
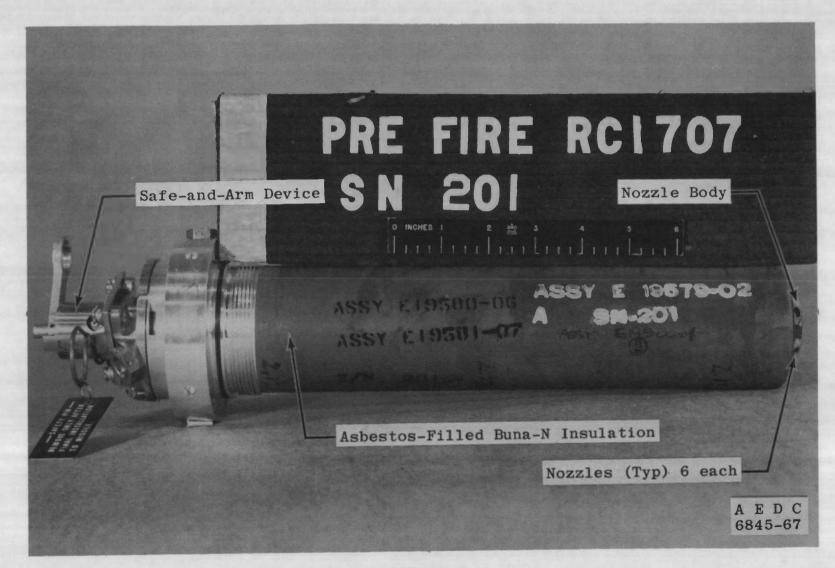
a. Schematic

Fig. 3 TE-P-358-3 Igniter

Ignition was accomplished by a TE-P-358-3 Pyrogen igniter (Fig. 3), which contained 19 gm of size 2A boron pellets used to initiate the eight-point-star igniter grain. The aft section of the igniter culminated in a nozzle body containing six small nozzles for distribution of the igniter propellant flame onto the motor propellant grain (Fig. 2a). The head end of the igniter contained a mechanical safe and arm device, two squib ports, one pyrogen pressure port, and one chamber pressure port. One McCormick Selph nominal 15-sec delay squib was used for the tests reported herein except for motor S/N T00002 for which two squibs were used. Nominal ignition current was 5 amp/squib and was maintained for approximately 0.3 sec.

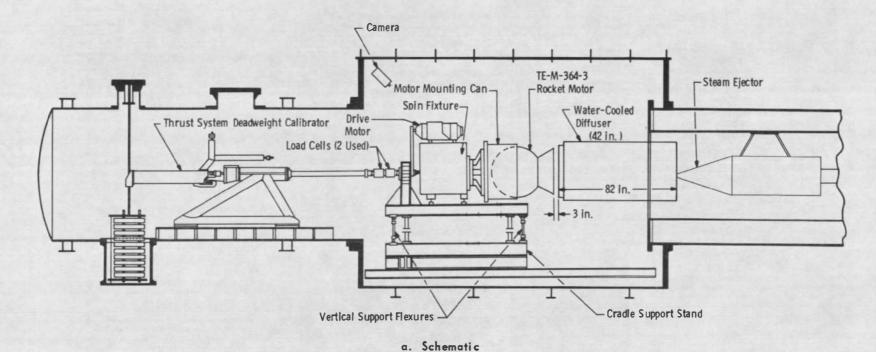
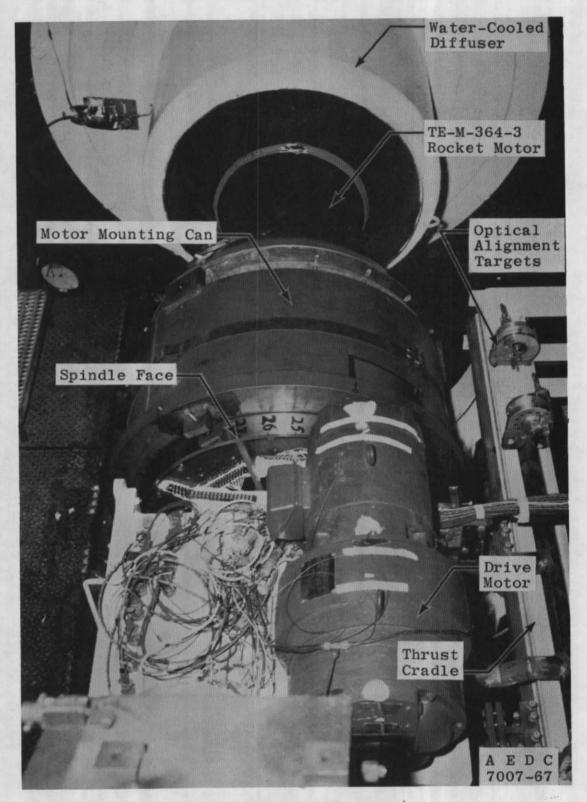
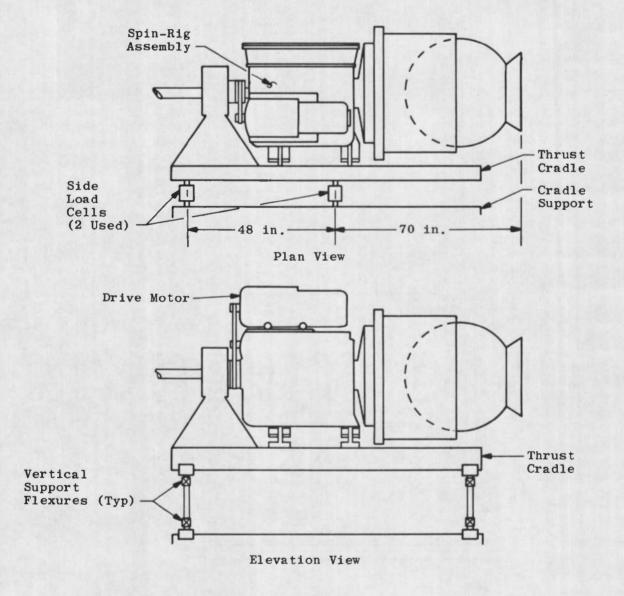
Fig. 4 Installation of the TE-M-364-3 Motor Assembly in Propulsion Engine Test Cell (T-3)

b. Photograph (Looking Downstream)Fig. 4 Continued

c. Detail Fig. 4 Concluded

The motors were cantilever mounted from the spindle face of a spin fixture assembly in Propulsion Engine Test Cell (T-3) (Ref. 3). The spin assembly was mounted on a thrust cradle, which was supported from the cradle support stand by three vertical and two horizontal double-flexure columns (Fig. 4). The spin fixture assembly consists of a 10-hp squirrel-cage-type drive motor, a forward thrust bearing assembly, a 46-in. -long spindle having a 36-in. -diam aft spindle face, and an aft bearing assembly. Each motor was secured in a mounting can which was adapted to the spindle face. For the spin firings, the spin fixture was rotated counterclockwise, looking upstream. For the no-spin firing the spin fixture was locked in place to prevent rotation. Electrical leads to and from the igniters, pressure transducers, and thermocouples on both motors were provided through a 170-channel, slip-ring assembly mounted between the forward and aft bearing assemblies on the spindle. Axial thrust was transmitted through the spindle-thrust bearing assembly to two load cells mounted just forward of the thrust bearing.

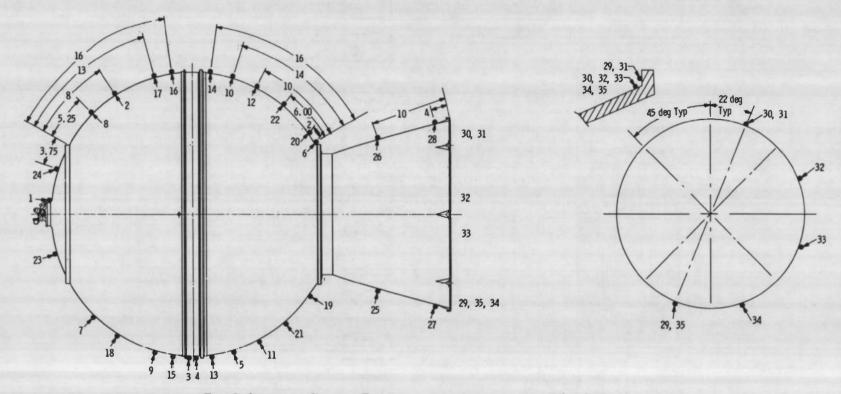
Fig. 5 Schematic Showing Thermocouple Locations on the TE-M-364-3 Motor

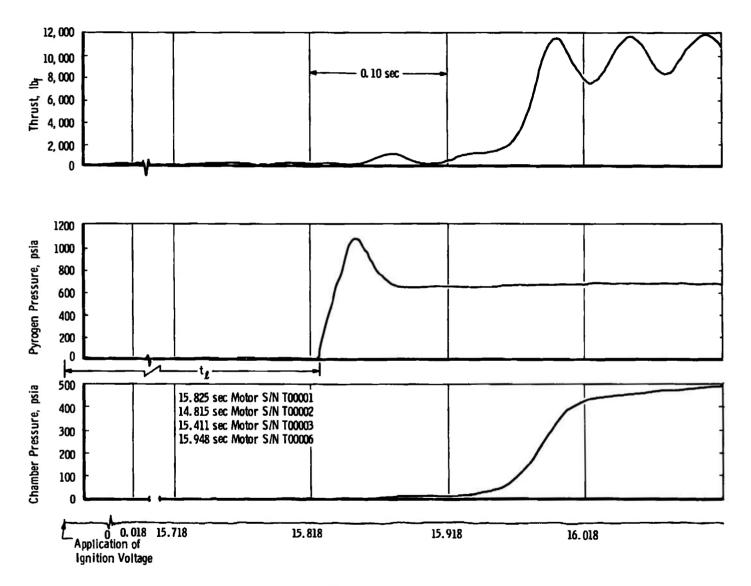
Fig. 6 Analog Trace of Typical Ignition Event

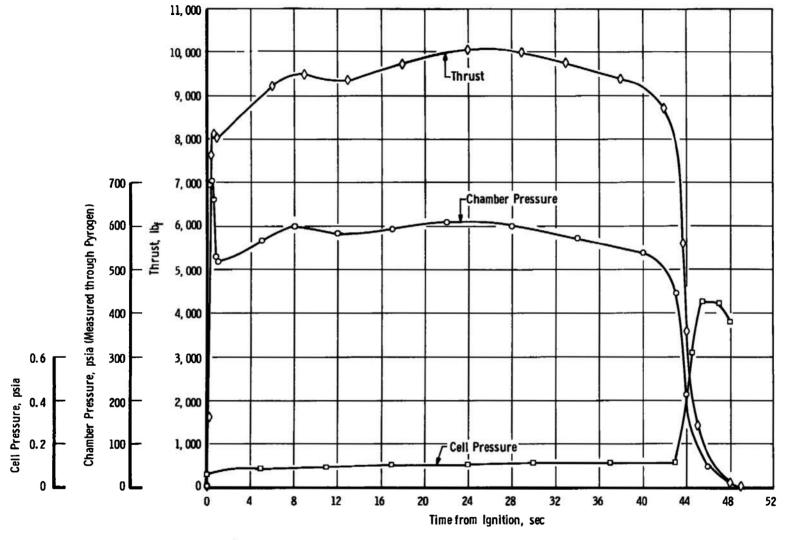
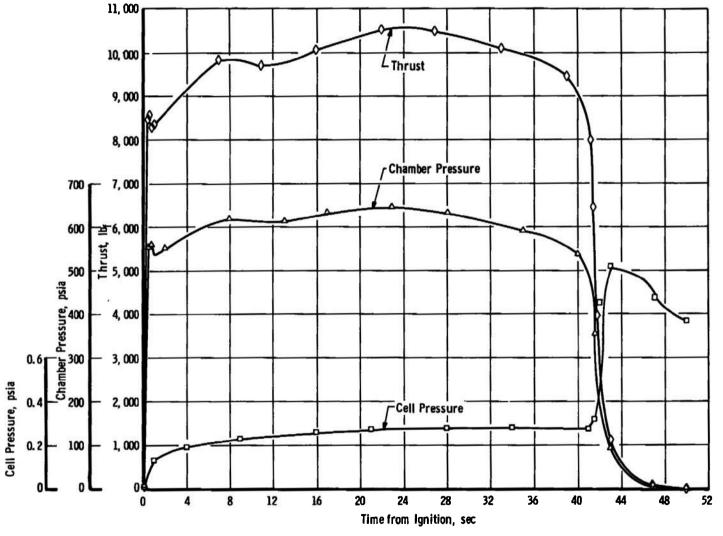
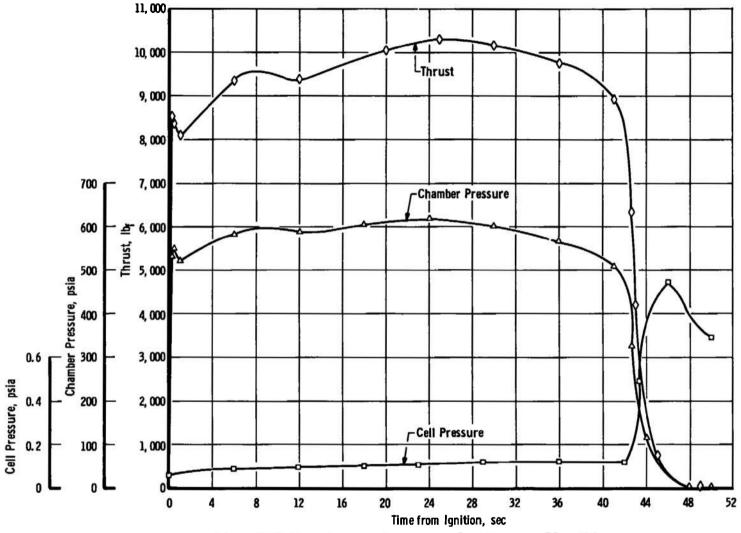
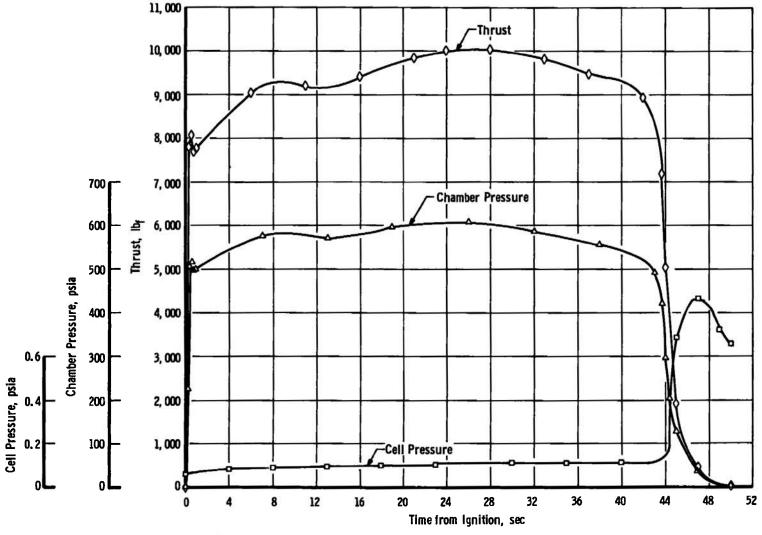
a. Motor S/N T00001 (Spin Mode, 110 rpm; Temperature Conditioned at  $55 \pm 5$ °F)

Fig. 7 Variations of Thrust, Chamber Pressure, and Test Cell Pressure during Motor Burn Time

b. Motor S/N T00002 (Spin Mode, 110 rpm; Temperature Conditioned at 95 ± 5°F)

c. Motor S/N T00003 (No-Spin Mode; Temperature Conditioned at 75 ± 5°F)

d. Motor S/N T00006 (Spin Mode, 110 rpm; Temperature Conditioned at 50  $\pm$  5°F)

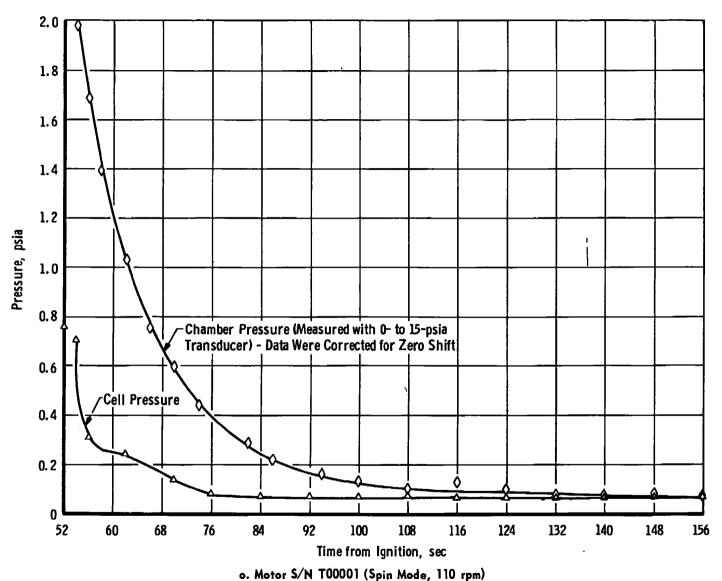
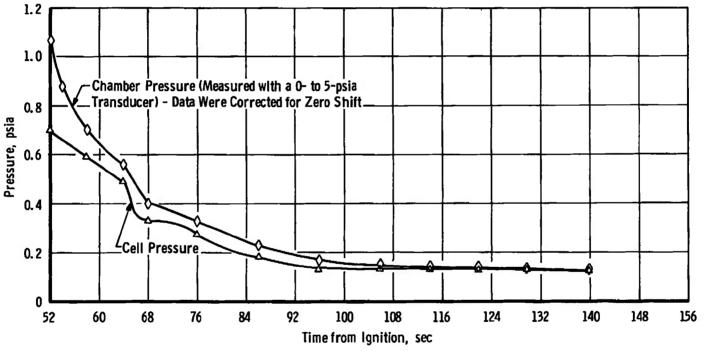
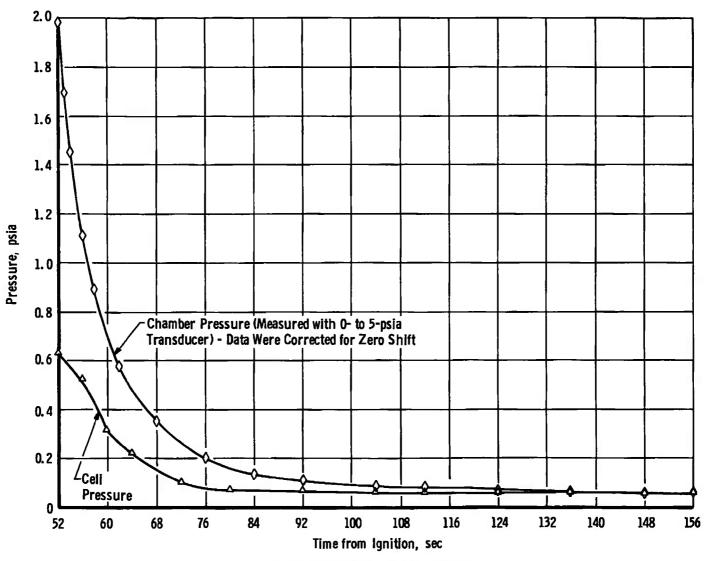
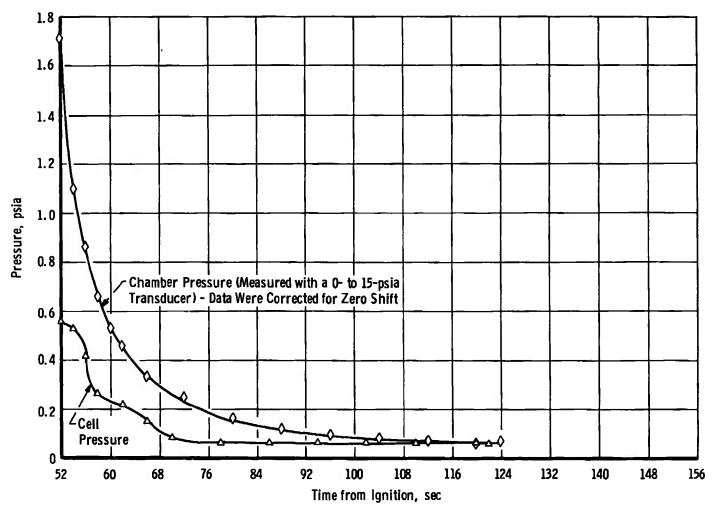
Fig. 8 Comparison of Low-Ronge Chomber Pressure and Test Cell Pressure during Motor Toiloff

Fig. 8b b. Motor S/N T00002 (Spin Mode, 110 rpm)
Fig. 8 Continued

c. Motor S/N T00003 (No-Spin Mode)

d. Motor S/N T00006 (Spin Mode, 110 rpm)

The low level chamber pressure measured after propellant burnout (approximately 50 sec after motor ignition) is believed to have resulted from residual burning propellant slivers and/or smoldering insulator material. There were no indications of increases in chamber pressure during the long tailoff period. Therefore, it is concluded that the motors did not experience any sporadic burning of propellant slivers after motor burnout. Post-fire inspection of motors S/N's T00002, T00003, and T00006 revealed eight small propellant slivers symmetrically located near the motor equator. No propellant slivers were evident during the post-fire inspection of motor S/N T00001.

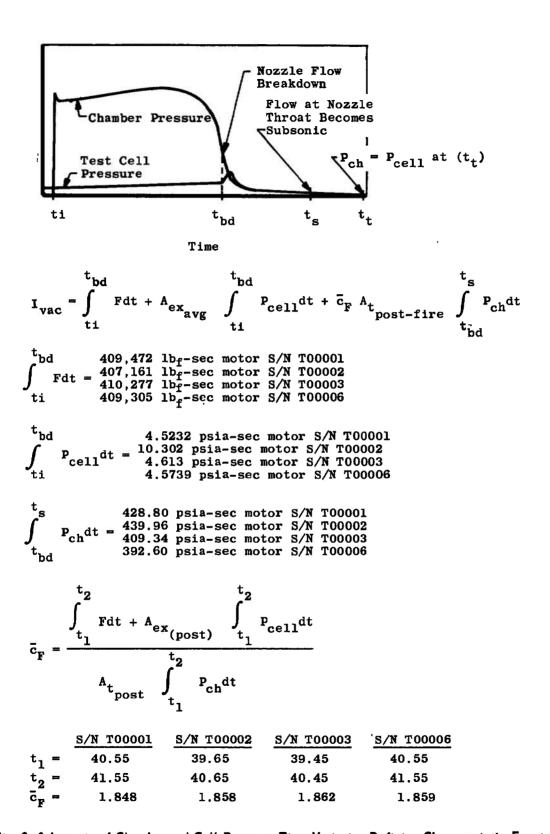
Fig. 9 Schematic of Chamber and Cell Pressure-Time Variation Defining Characteristic Events

The time interval  $(t_1 \text{ to } t_2)$  is a one-second interval of motor operation just prior to decrease in chamber pressure (Fig. 9). The impulse accumulated between the time that the nozzle throat flow becomes subsonic  $(t_s)$  and the end of burn time  $(t_t)$  is considered negligible. Performance characteristics for the four motors are tabulated below along with the performance characteristics of the two previous motor firings reported in Ref. 2:

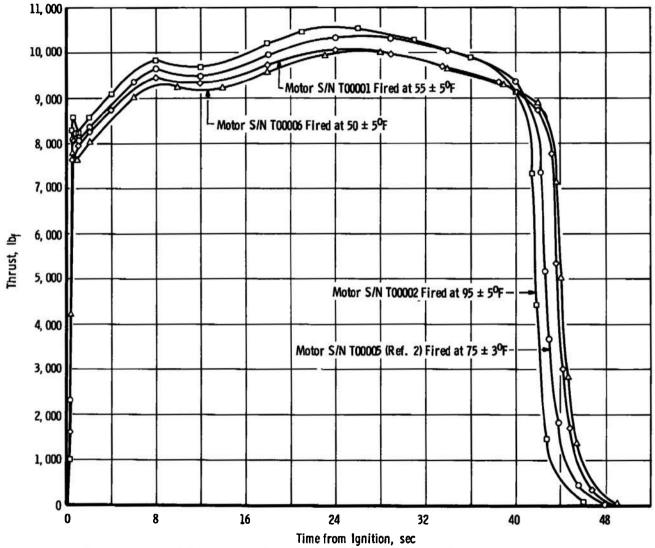
Fig. 10 Comparison of TE-M-364-3 Thrust Variation from the Three Spin Firings Reported Herein and the Ref. 2 Spin Firing

A comparison of the thrust variations for the three spin motor firings reported herein and the spin motor firing reported in Ref. 2 as a function of time is presented in Fig. 10. Propellant burn rate as a function of the pre-fire temperature conditioning level of the propellant grains is most evident in Fig. 10. For example, motor S/N T00002, which was pre-fire temperature conditioned at  $95 \pm 5^{\circ}$ F, achieved a maximum thrust level of 10, 550 lbf, whereas motor S/N T00006, which was pre-fire temperature conditioned at  $50 \pm 5^{\circ}$ F, achieved a maximum

thrust level of 10,010 lbf. Consequently, motor S/N T00002 experienced a shorter burn time (approximately 2 sec) than motor S/N T00006.

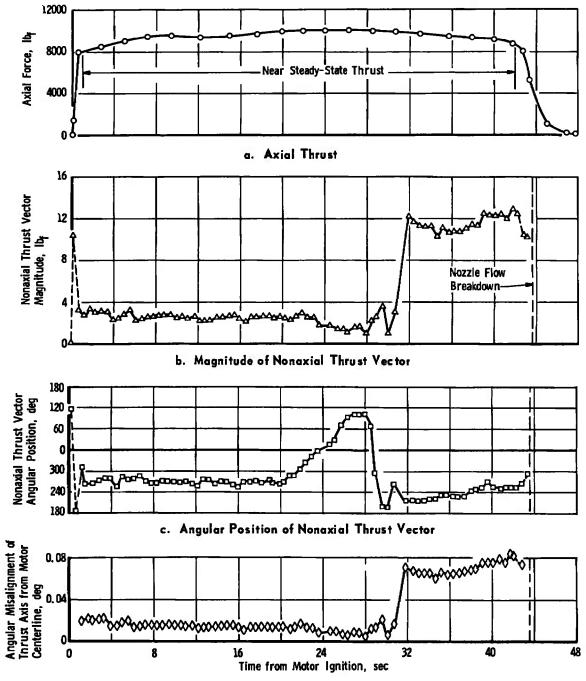
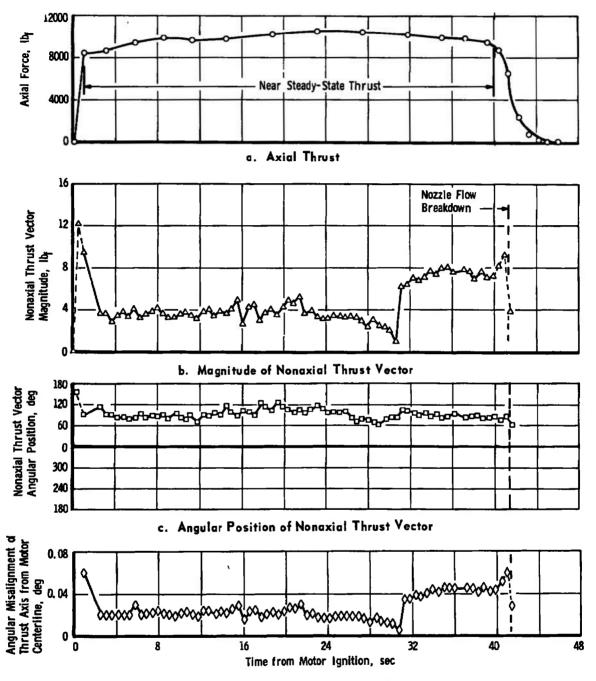
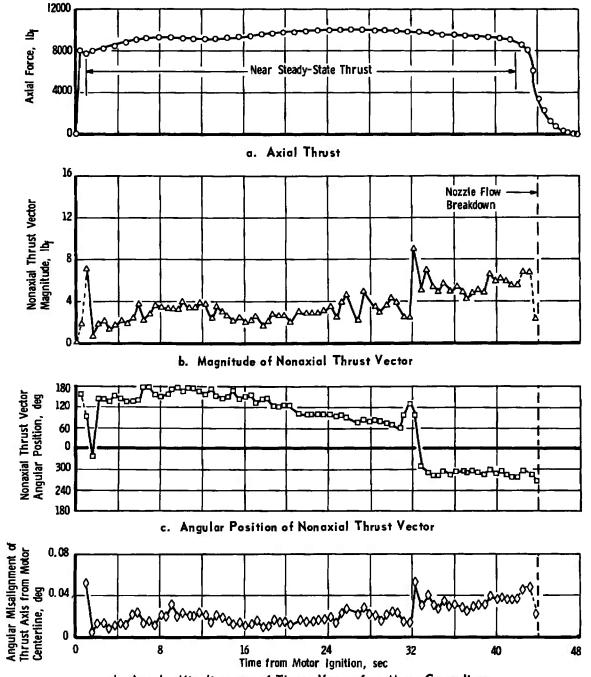
d. Angular Misalignment of Thrust Vector from Motor Centerline Fig. 11 Nonaxial Thrust Variation with Time for Motor S/N T00001

d. Angular Misalignment of Thrust Vector from Motor Centerline Fig. 12 Nonaxial Thrust Variations with Time for Motor'S/N T00002

d. Angular Misalignment of Thrust Vector from Motor Centerline
Fig. 13 Nonaxial Thrust Variations with Time for Motor S/N T00006

The nonaxial thrust data presented in Figs. 11 through 13 were corrected for nonaxial force caused by misalignment of the motor on the spin fixture. The angular misalignments of the motor centerline with respect to the spin axis were 0.0066, 0.0202, and 0.0244 deg for motors S/N's T00001, T00002, and T00006, respectively. The respective nonaxial thrust corrections resulting from these angular misalignments were approximately 1.1, 3.5, and 4.2 lbf at each maximum thrust level.

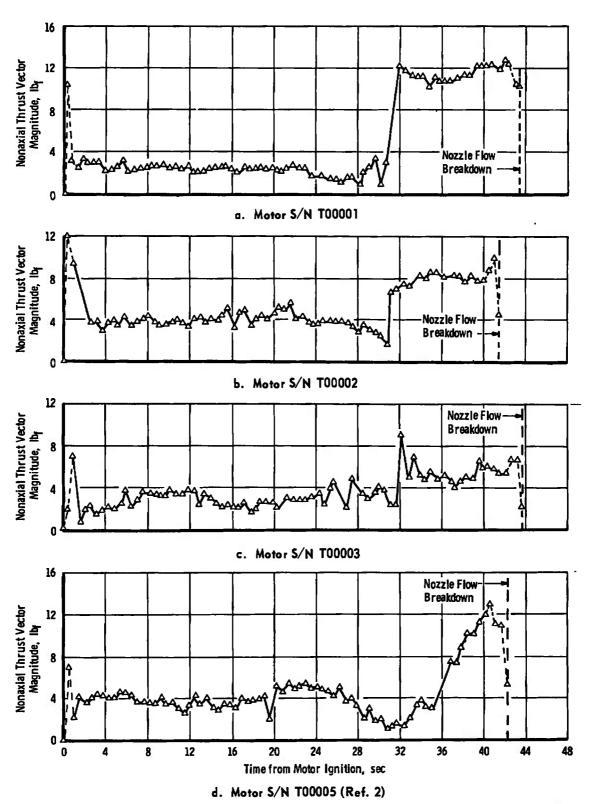
Fig. 14 Comparison of Nonaxial Thrust Vector Magnitude Time Variation for the Three TE-M-364-3 Spin Firings Reported Herein and the One Reported in Ref. 2

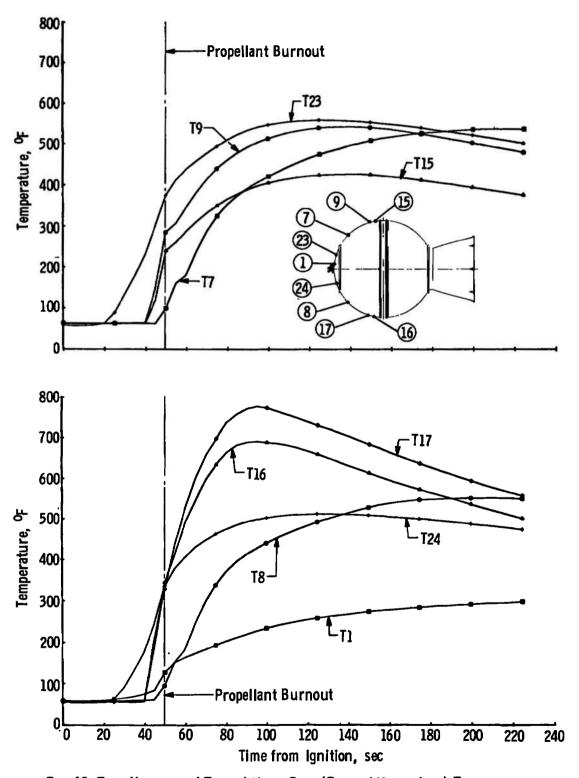
Fig. 15 Time Variation of Typical Motor Case (Forward Hemisphere) Temperatures

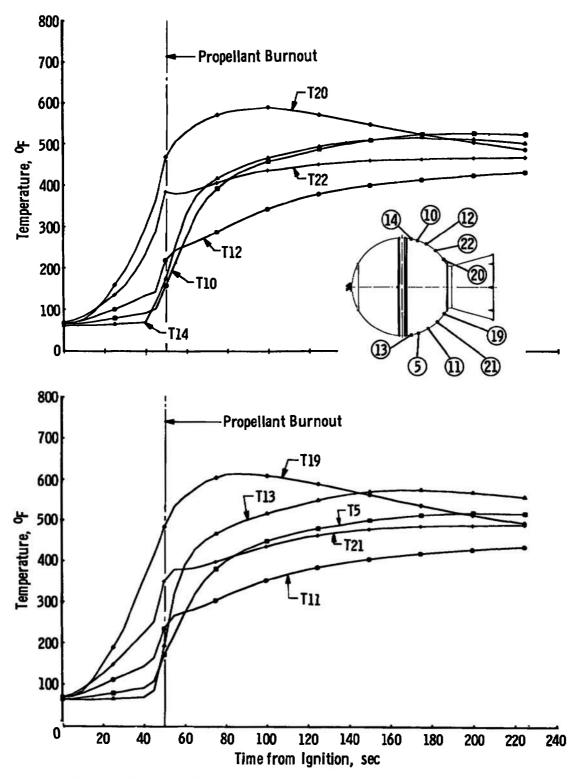
Fig. 16 Time Variation of Typical Motor Case (Aft Hemisphere) Temperatures

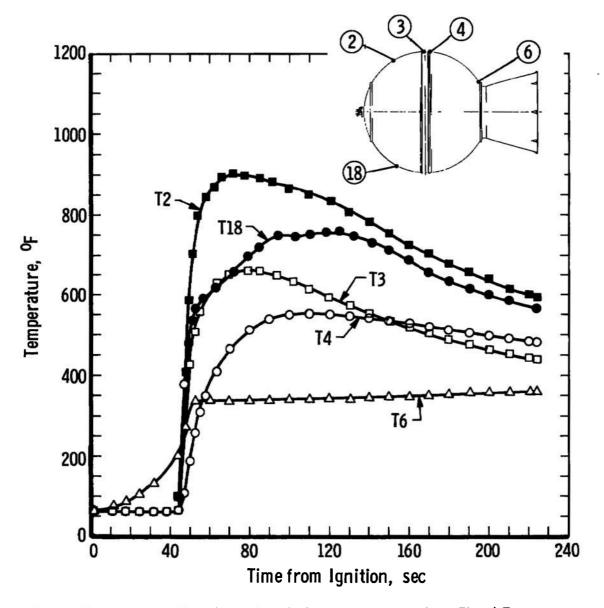
Fig. 17 Time Variation of Typical Motor Case (Midsection and Nozzle Adapter Flange) Temperatures

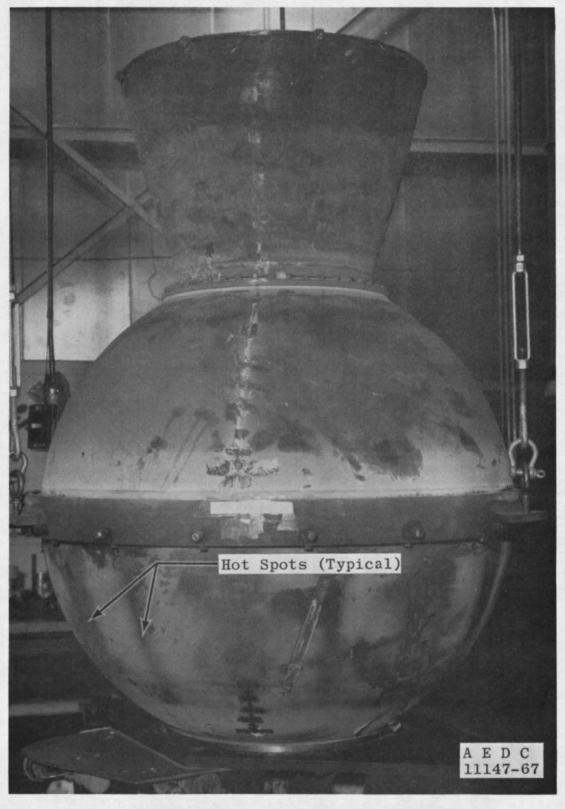
Fig. 19 Post-Fire Photograph of Motor S/N T00001 Showing Hot-Spots on Forward Hemisphere

Post-fire examination of the four motors did not reveal any distortion of or thermal damage to the motor cases. However, each motor had several small hot-spots located at or near the motor equator. Motor S/N T00001 also had evidenced eight pronounced hot-spots located just forward of the motor equator on the forward hemisphere (Fig. 19).

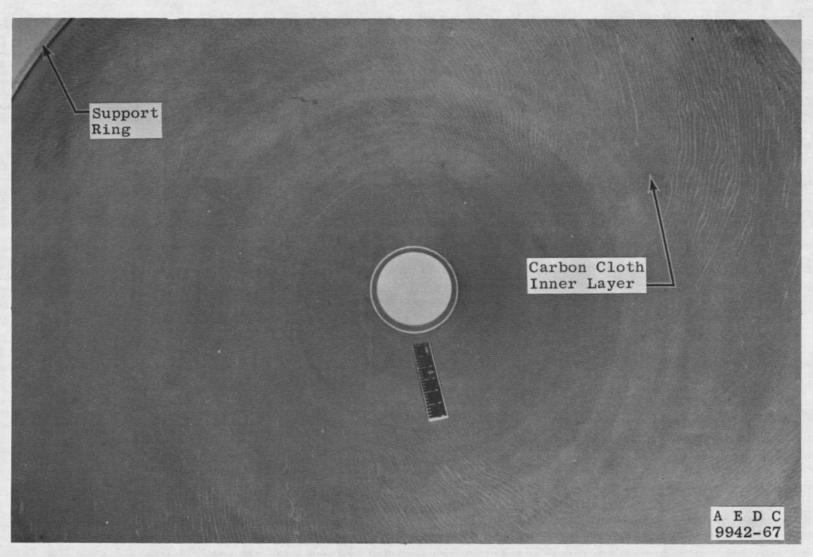
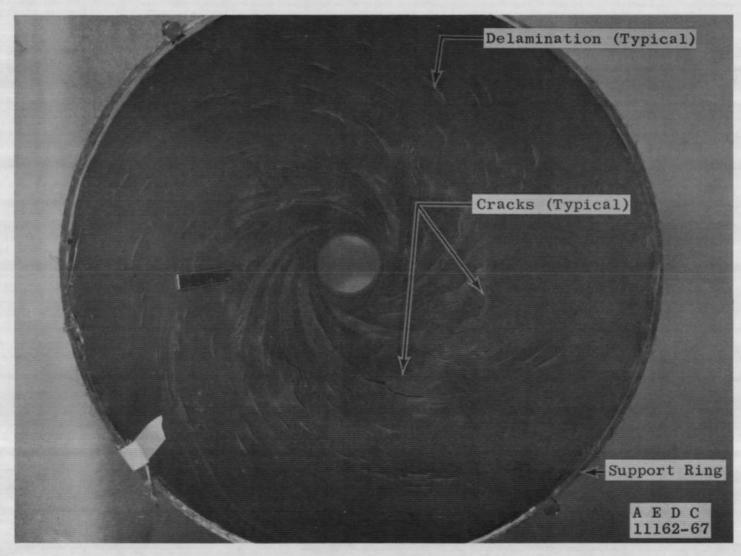
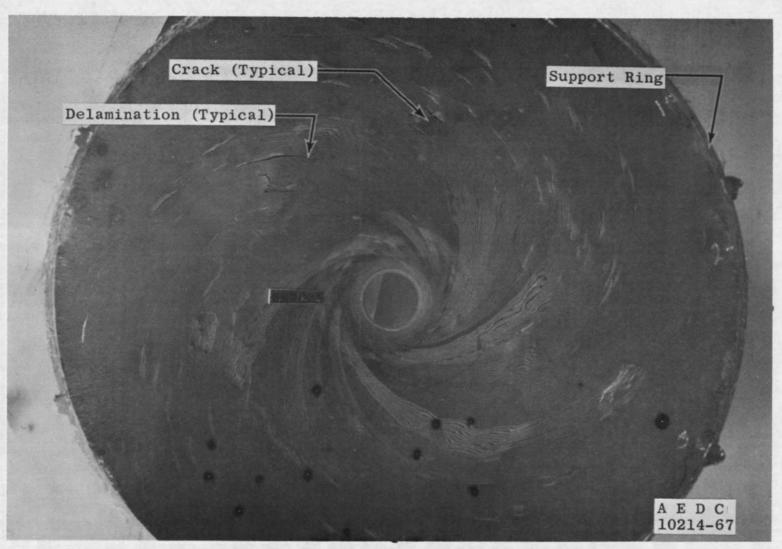
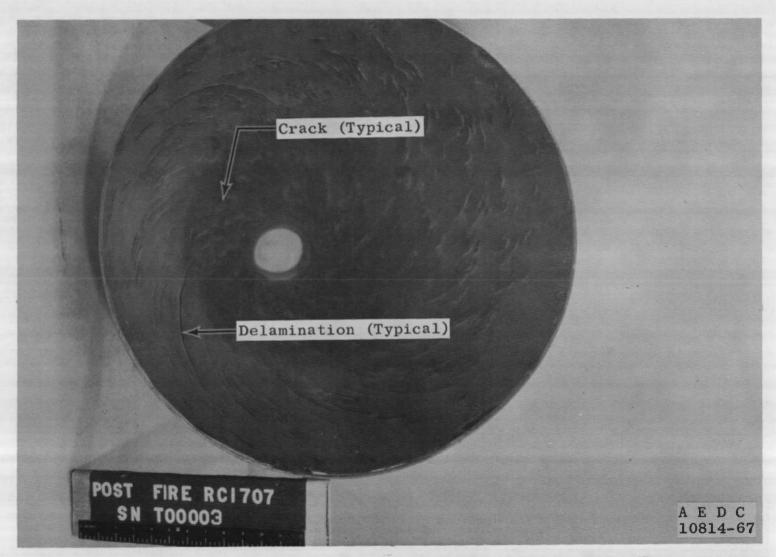
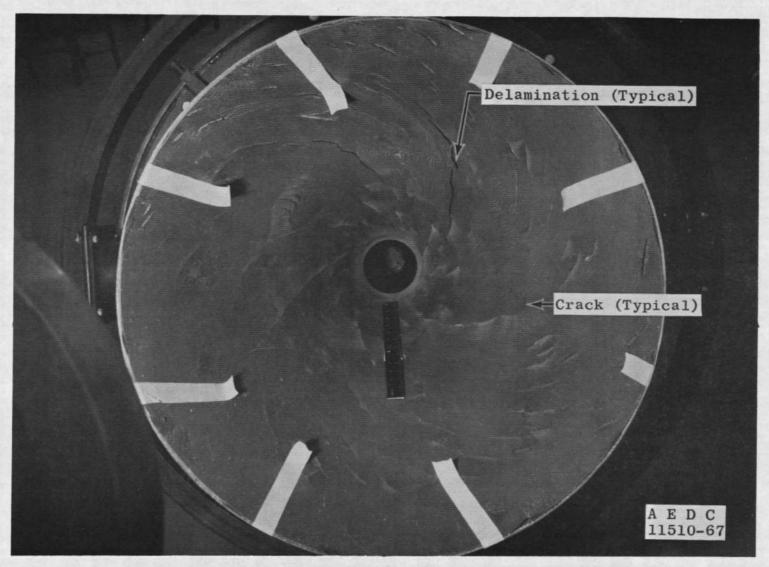
a. Typical Pre-Fire
Fig. 20 Nozzle Exit Cone Interior Condition

b. Post-Fire Motor S/N T00001 Fig. 20 Continued

c. Post-Fire Motor S/N T00002 Fig. 20 Continued

d. Post-Fire Motor S/N T00003 Fig. 20 Continued

e. Post-Fire Motor S/N T00006 Fig. 20 Concluded

Each of the four nozzle exit cones experienced thermal damage as was evidenced by delamination and cracking of the inner layers of carbon cloth phenolic (Fig. 20) and flaking of the outer layers of glass cloth phenolic (Fig. 21). Post-fire examination of the Ref. 2 motors revealed similar thermal damage to the nozzle exit cones. Nozzle throat measurements indicated that erosion had caused an increase of 8.69, 8.88, 11.1, and 8.97 percent from the pre-fire areas of motors S/N's T00001, T00002, T00003, and T00006, respectively.

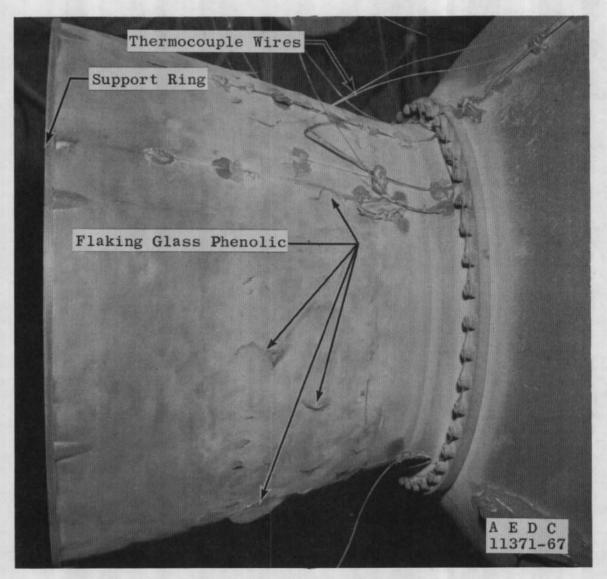
Fig. 21 Typical Nozzle Exit Cone Exterior Condition

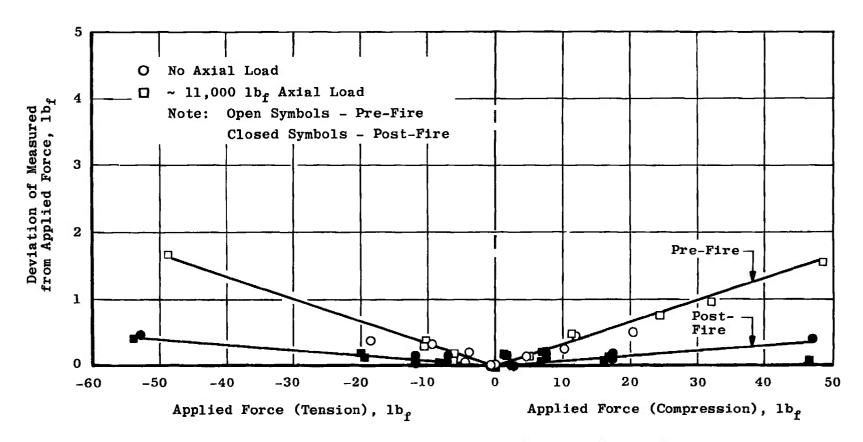
Fig. III-1 Comparison of Measured and Applied Static (Lateral) Force for Pre- and Post-Fire Motor S/N T00005

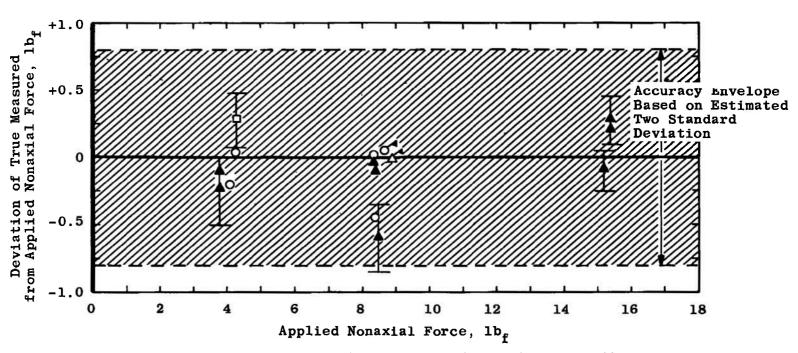
Fig. III-2 Comparison of True Measured and Applied Nonaxial Force Values for Spin Calibration to Determine System Accuracy

A comparison of true measured and applied nonaxial force is presented in Fig. III-2. The true measured force presented is an average of 10 values. Typical envelopes of the data points used in the averages are presented and incorporated into the accuracy determination. The maximum deviation of true measured from applied nonaxial force of 0.60 lbf was observed at an applied nonaxial force of 8.50 lbf. The system accuracy, based on an estimated two-standard deviation for the test reported herein, was ±0.80 lbf at the steady-state thrust level.

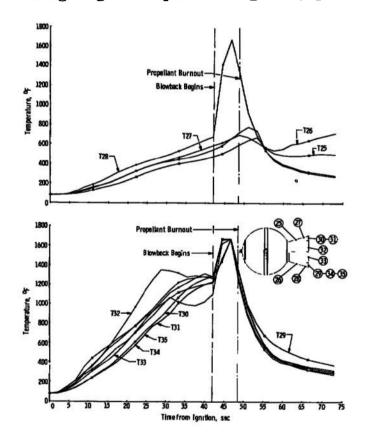
Fig. 18 Time Variation of Typical Nozzle Temperatures

The following figure replaces Fig. 18, p. 47:
